Issued February 9, 2023

MIR-23-04

Contact of *Miss Mollye D* Tow with Route 182 Bridge

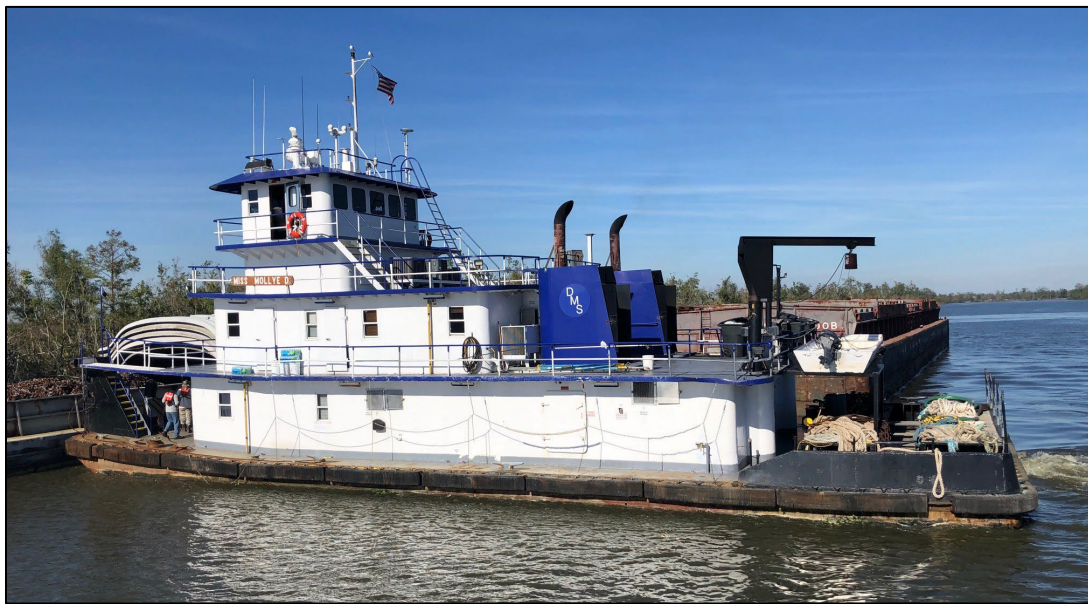
Figure 1. *Miss Mollye D* moored following the casualty. (Source: US Coast Guard)
